Manhole Inspection Summary

Manhole # S29EE_028MH

Inspection ☐ Is Incomplete Rating: **3) Fair**

Location Address: **1501 MOSHER ST**

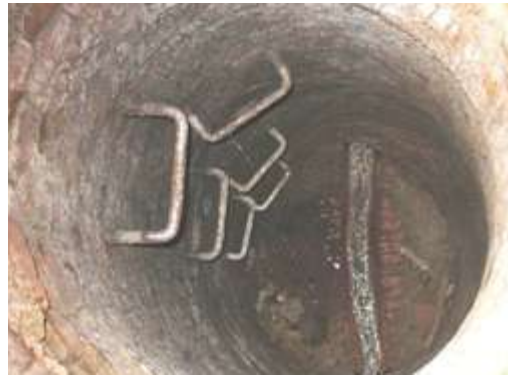
Top View

Frame leaks. Adjustment deterioration and infiltration. Barrel infiltration. Bench and Channel debris.

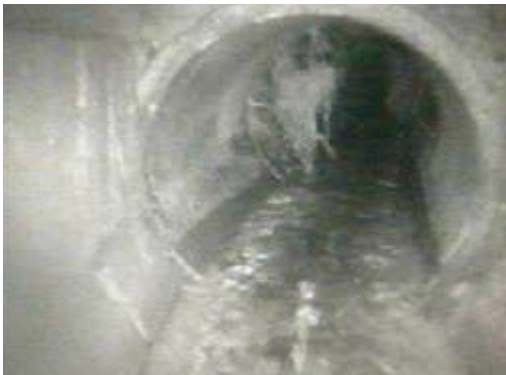
Inside the O12

Joint root intrusion.

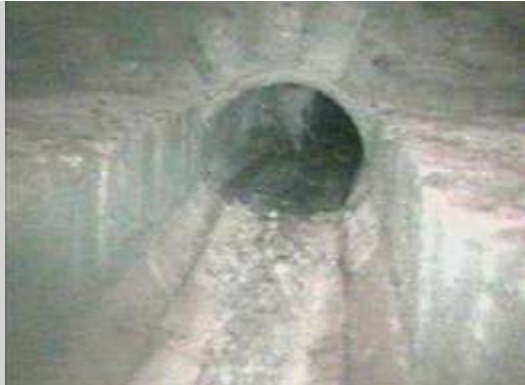
8 in. Circular Gravity Sewer Pipe Out @ 12 O'Clock

Deposits: ☐ None ☒ **Mud** ☐ Sludge ☐ **Debris** ☒ **Grease**

Silt Depth: **0.5** (in.) Deposits Extent: **Light**

Infiltration: **None** Pipe Seal Cond: **Unknown**

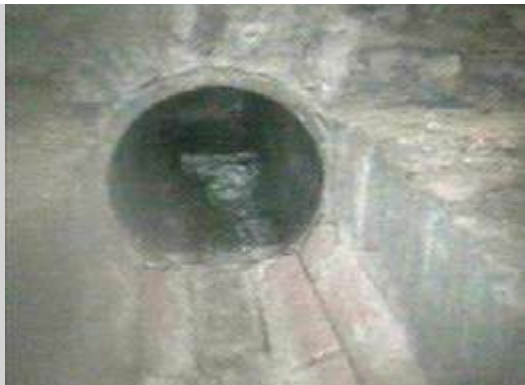
8 in. Circular Gravity Sewer Pipe In @ 6 O'Clock

Deposits: ☐ None ☒ **Mud** ☐ Sludge ☒ **Debris** ☐ Grease

Silt Depth: **0** (in.) Deposits Extent: **Light**

Infiltration: **Evidence** Pipe Seal Cond: **Unknown**
